# 2019 CROOKED RIVER WATER QUALITY REPORT

*Deschutes River Alliance*  
*April 2020*

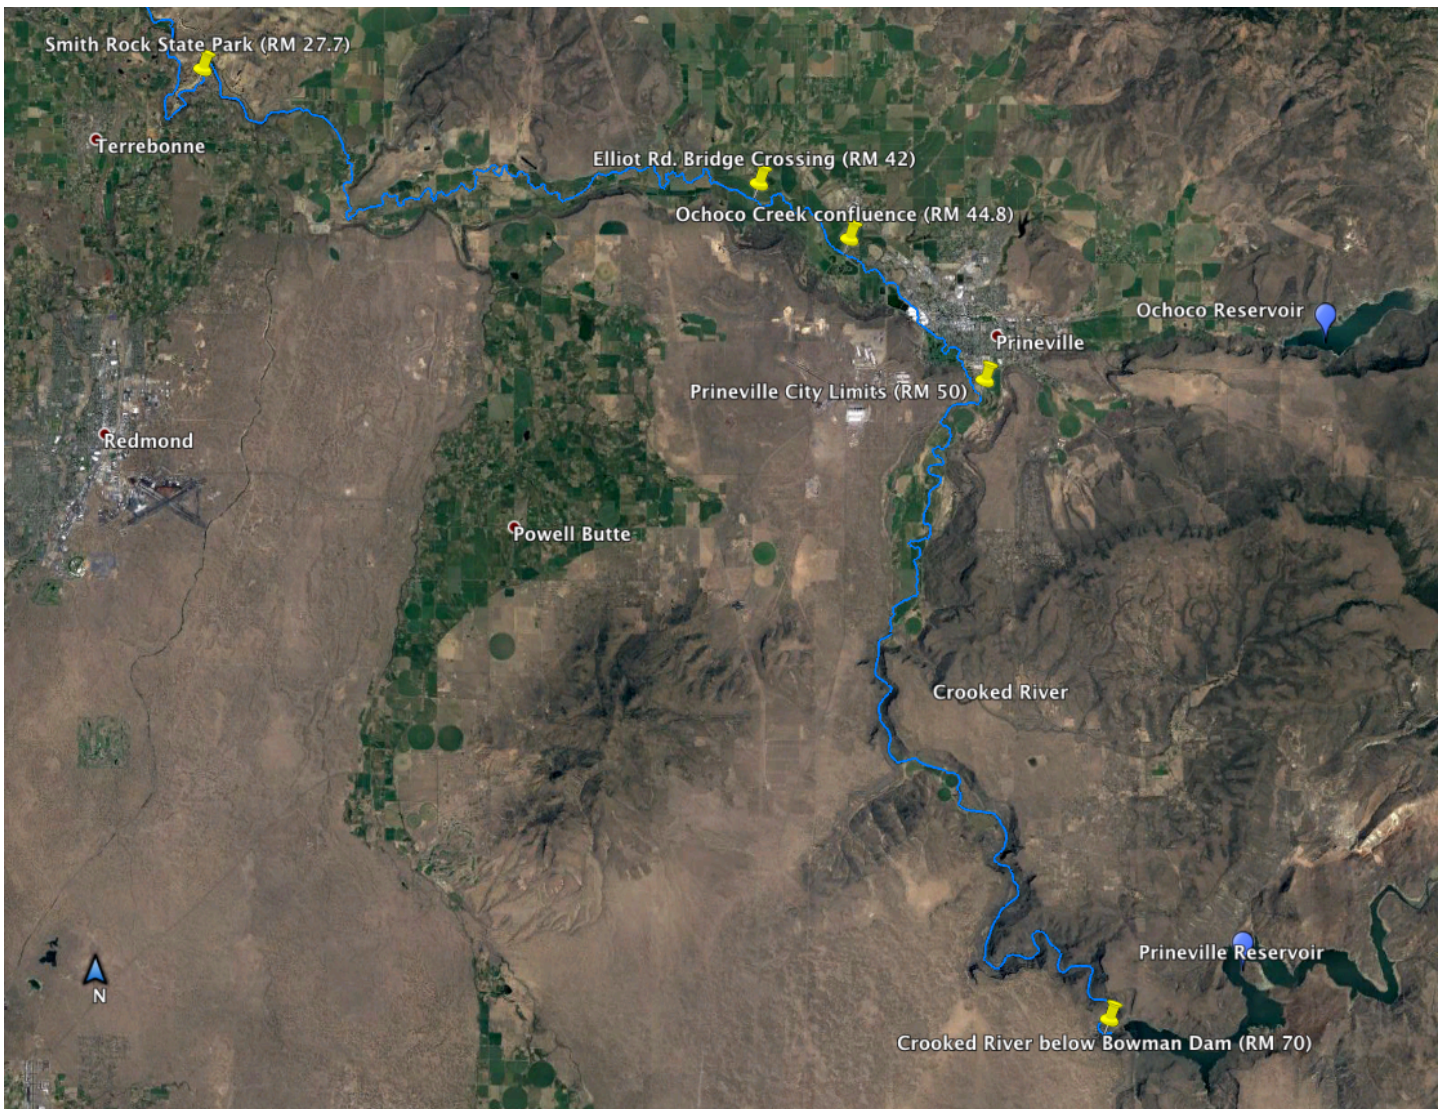
Figure 2. Lower Crooked River sub-basin and 2019 monitoring sites.

The DRA water quality study focused on the lower Crooked River sub-basin from Bowman Dam (RM 70) to Smith Rock State Park (RM 27, Figure 2). The monitoring sites were selected based on sites used by the local watershed council and Oregon DEQ in prior studies.

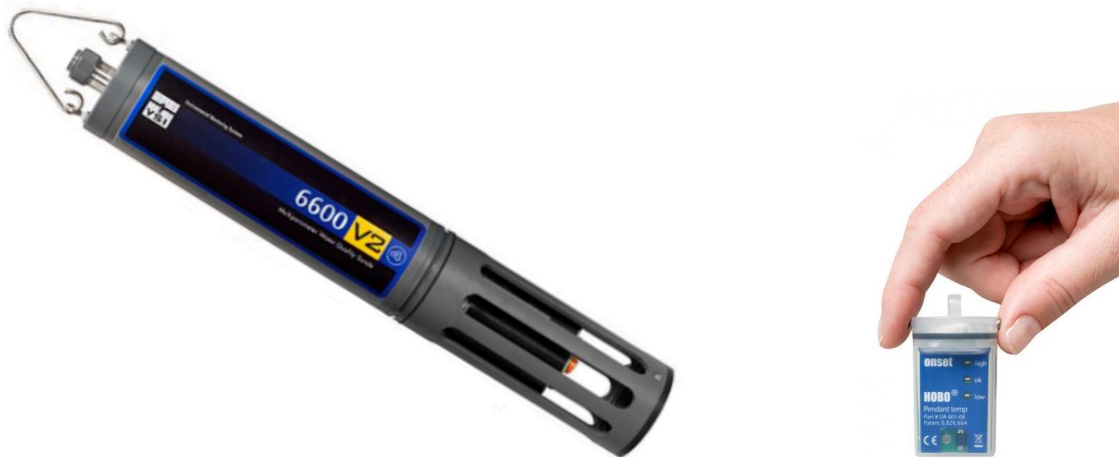
**Figure 3.** YSI 6600v2 data sonde (left) and Onset® HOB0® Pendant data logger (right).

Four temperature data loggers (Onset® HOB0® Pendant model) were used to record hourly in-stream water temperature data and a multi-parameter data sonde (YSI 6600v2 model) was used to record hourly in-stream water quality data including water temperature, pH, dissolved oxygen, turbidity, and chlorophyll-*a* (Figure 3). The temperature data loggers were deployed at sites 1-4 in the Crooked River between Bowman Dam and the City of Prineville from July 26 through November 7, 2019 (Table 1). The data sonde was successfully deployed at site 5 (Smith Rock State Park) from August 22 through December 6, 2019 (Table 1).

Equipment was programmed for 60-minute data collection intervals. Metal cables were used to fix the data loggers to the bank. Data loggers were placed mid-stream at a depth of approximately 2-3 feet. All the study sites were located in flat-water, non-turbulent segments of river with laminar flow. Information collected at each monitoring site included site name, date/time, GPS coordinates, site photos, site description, logger serial number, and the appropriate audit information.

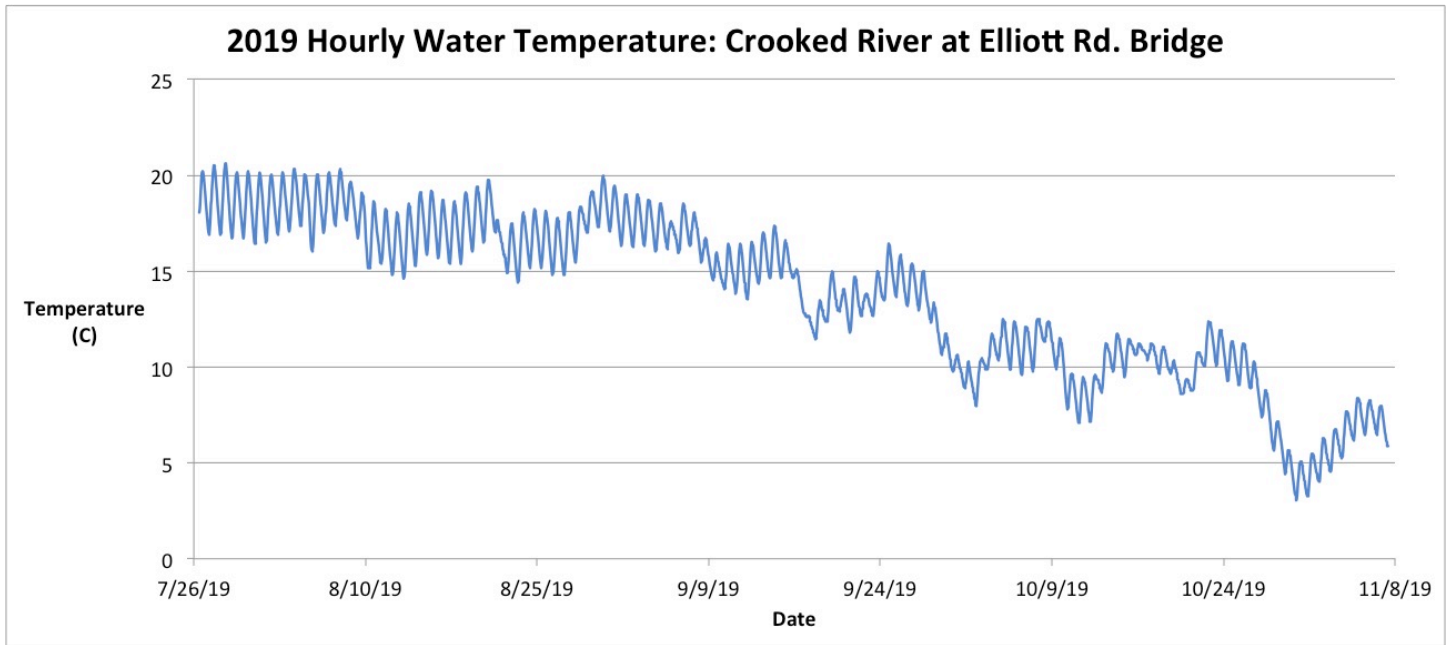
Figure 6 shows the results from RM 42 of the Crooked River at the Elliott Road Bridge. This site is approximately two miles downstream from the confluence of McKay Creek. The maximum diel range at this site was 4.00°C (~7.2°F) on August 5, 2019. The minimum diel range at this site was 0.59°C (~1°F) on October 16, 2019. The average diel range was 2.40°C (~4.3°F). The maximum recorded temperature was 20.61°C (69.1°F) on July 28, 2019 at 1800 hours. The minimum recorded temperature was 3.05 °C (37.5°F) on October 30, 2019 at 0900 hours.

**Figure 6.** 2019 Crooked River hourly water temperature at Elliott Rd. Bridge (RM 42).

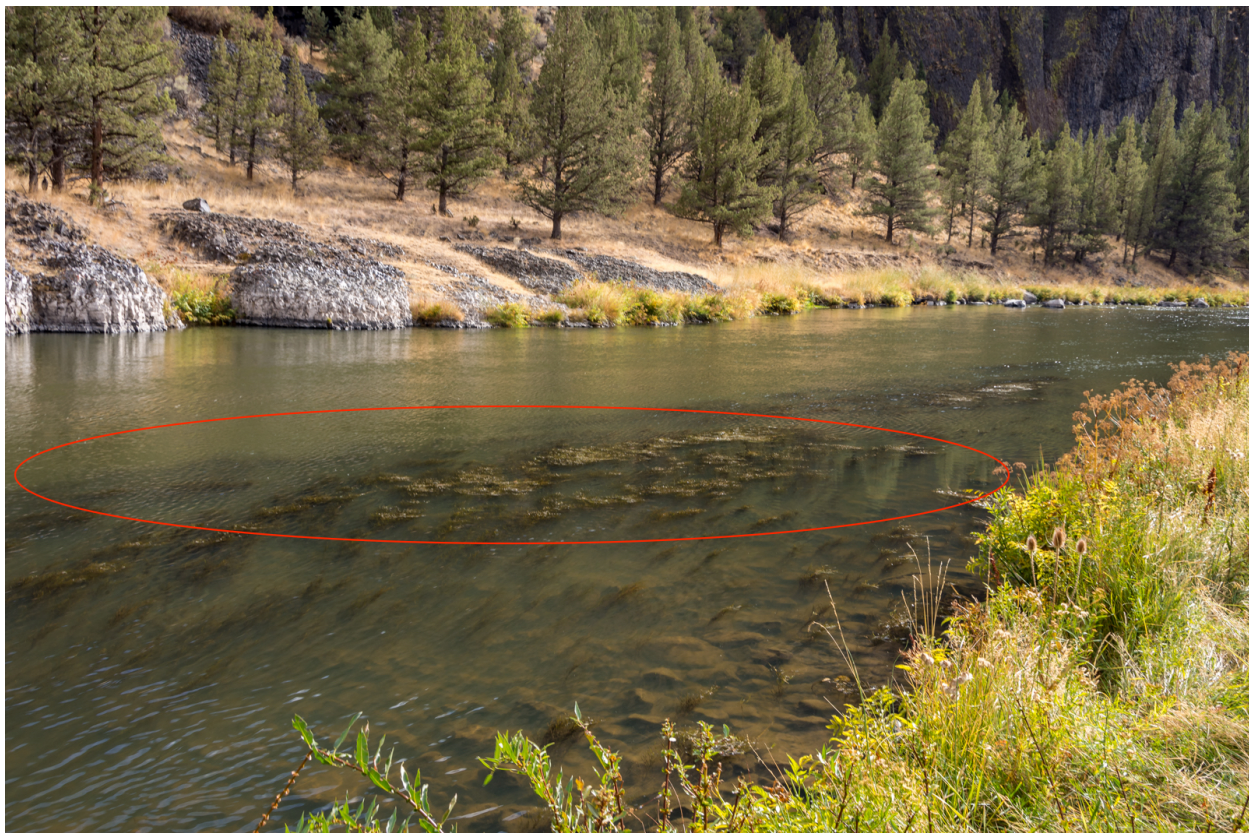
**Figure 10.** Crooked River below Bowman Dam (RM 65). Excessive aquatic plant and algae production is circled in red. Photo by: Rick Hafele

As algae and aquatic plant biomass increases, the difference between the daily minimum and daily maximum pH also increases. The pH measurements collected during this study at RM 27 of the Crooked River showed large diel swings from late summer through fall (Figure 9). These results indicate that excess nutrients are contributing to high biomass production. In addition, excessive algae, fungus, and bacteria growth known as periphyton was observed at the study sites and are a common visual indicator of nutrient enrichment (EPA 2013). Figure 10 shows an example of the dense growths of aquatic vegetation and algae as a result of nutrient enrichment.
