# 2015 LAKE BILLY CHINOOK WATER QUALITY STUDY RESULTS

*Prepared for Deschutes River Alliance  
by Rick Hafele - February 2016*

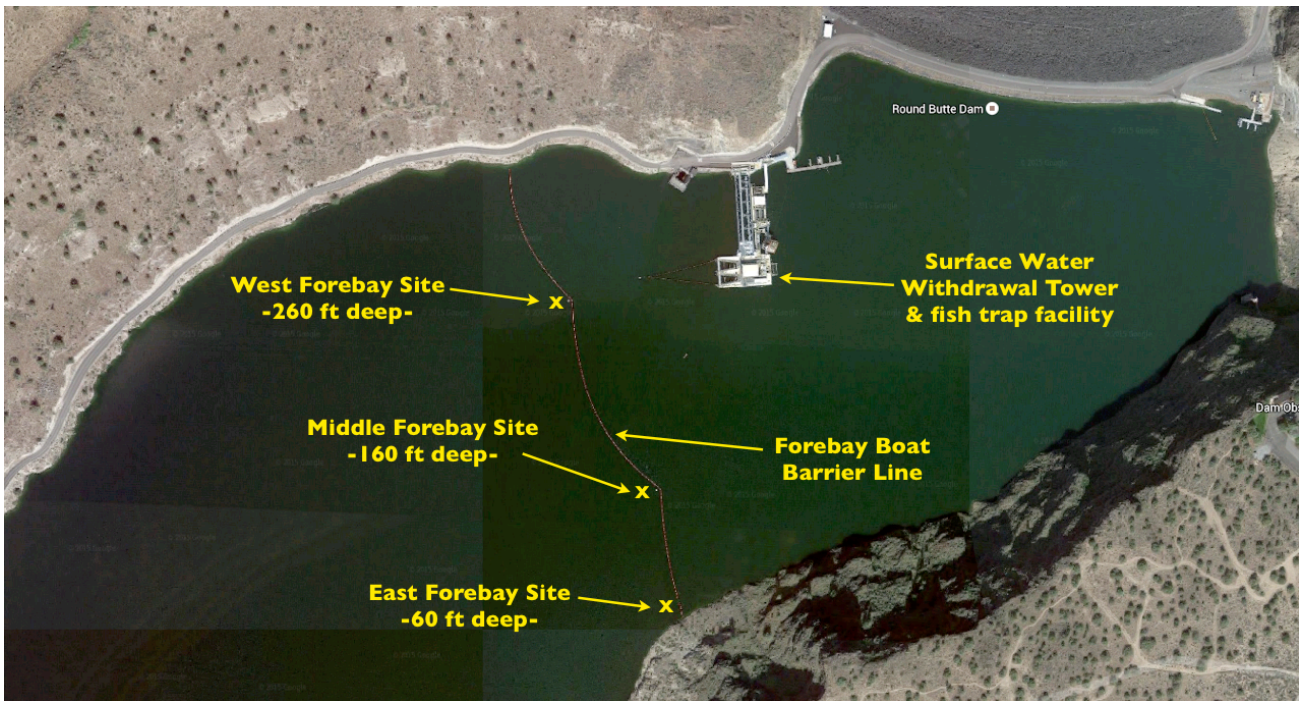
Figure 3. Forebay sample sites at Round Butte Dam.

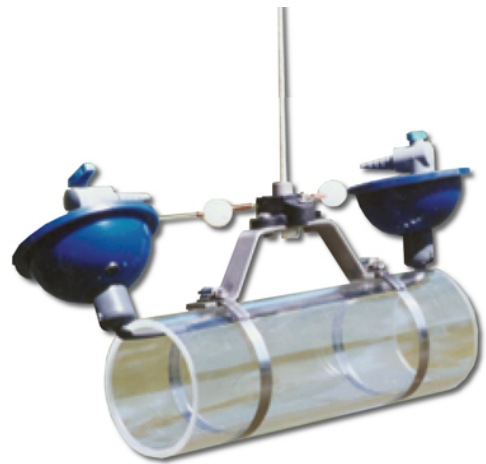
**Figure 4.** Van Dorn Sampler

Water samples were collected with a Van Dorn sampler (Figure 4). Upon reaching the sample site the Van Dorn sampler was lowered to the appropriate depth on a nylon cord. Surface samples were collected three feet deep. Bottom samples were collected a few feet above the reservoir bottom. The depth of the three sites near the forebay varied: East bank depth - 60 feet; Middle site depth - 160 feet; West bank depth - 260 feet. As shown in Figure 3, the SWW tower is located along the west bank of the reservoir with the depth of the bottom intake on the tower at approximately 260 feet.

Once the Van Dorn sampler was retrieved from the sample location, water was drawn from the sampler and placed in one of three sample bottles. These bottles were placed on ice and returned to Umpqua Research Co. by 3:00pm the same day for nutrient and chlorophyll-*a* analysis. Remaining water in the sampler was placed in a rinsed plastic beaker for pH and temperature measurements. The pH was measured with a Hana Instruments pH meter model 991001. Temperature was measured with a Thomas Scientific temperature meter model 1235C88. A final water sample was placed in a glass vial provided with the Hana Instruments turbidity meter (model 98703) and a turbidity measurement taken. After recording the time, location, and field measurements, the Van Dorn sampler was lowered to the next sample location.

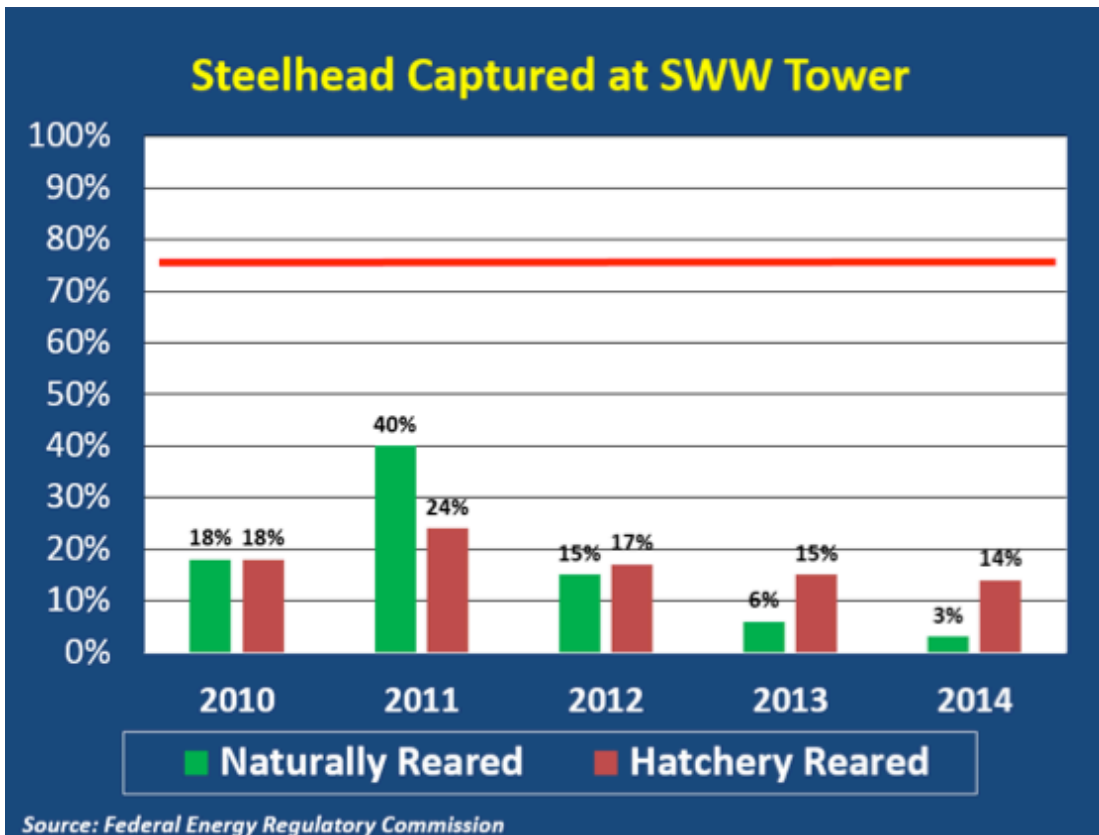
**Figure 5.** Steelhead survival rates of smolts traveling through Lake Billy Chinook reservoir and captured at the SWW trap facility. (From Hill et al. 2014)

at the mouths of the three tributaries and subsequently collected at the SWW trap after swimming through LBC. The red line in each graph represents the 75% survival objective for migrants through LBC identified in the federal operating license (FERC license, pages 146, 161). “Naturally reared” means the fish were released as fry in the upper Deschutes basin where they reared in the watershed before migrating downstream as smolts. “Hatchery reared” means the fry were raised in hatcheries where they were fin clipped and released as full term smolts in the tributaries to out-migrate.

Hatchery reared smolts survived passage through LBC better than naturally reared fish, but the survival of all steelhead and spring Chinook through the reservoir was low, and considerably below the 75% objective. For example, survival of naturally reared steelhead migrating through LBC in 2014 was extremely low, with only 3% of them being recaptured at the SWW trap (Figure 5). Hatchery reared steelhead smolts had a 14% survival rate in comparison. Spring Chinook smolts had survival rates through the reservoir of

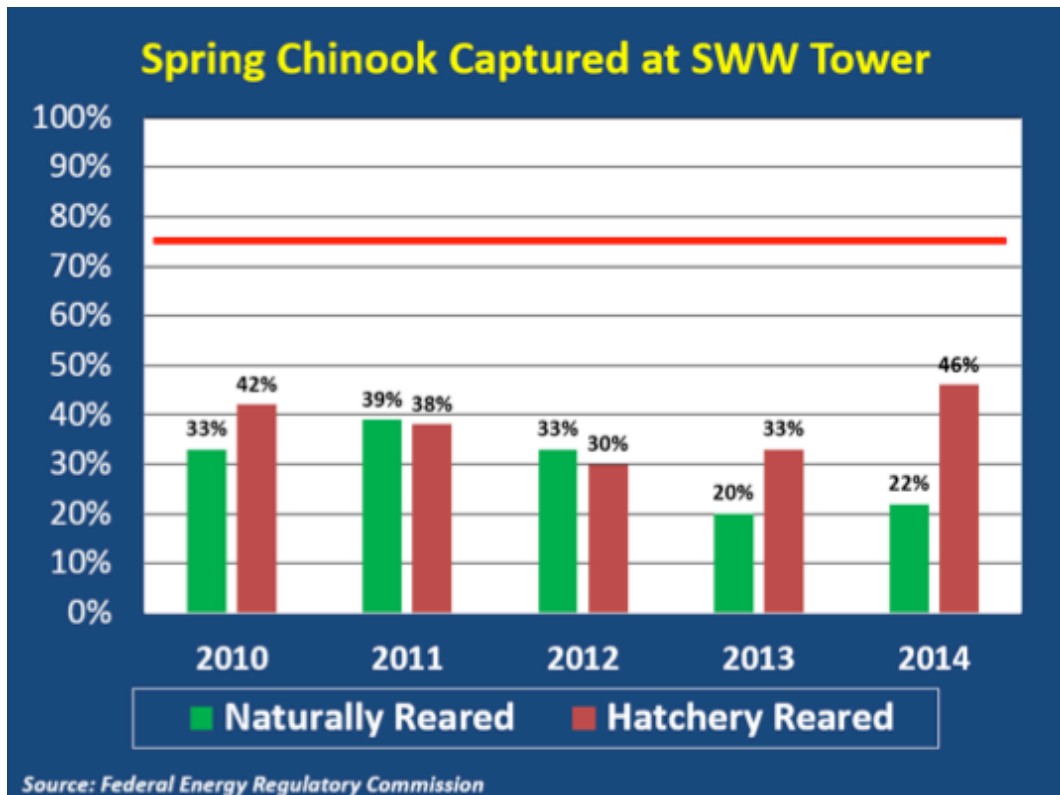
**Figure 6.** Spring Chinook survival rates of smolts traveling through Lake Billy Chinook reservoir and captured at the SWW trap facility. (From Hill et al. 2014)

22% and 46% in 2014 for naturally reared and hatchery reared smolts, respectively (Figure 6).
